# **Predictive Service Life Tests for Roofing Membranes**

## **Phase II Investigation of Accelerated Aging Tests for Tracking Degradation of Roofing Membrane Materials**

David M. Bailey, Carl G. Cash, and Arthur G. Davies, Jr.

September 2002

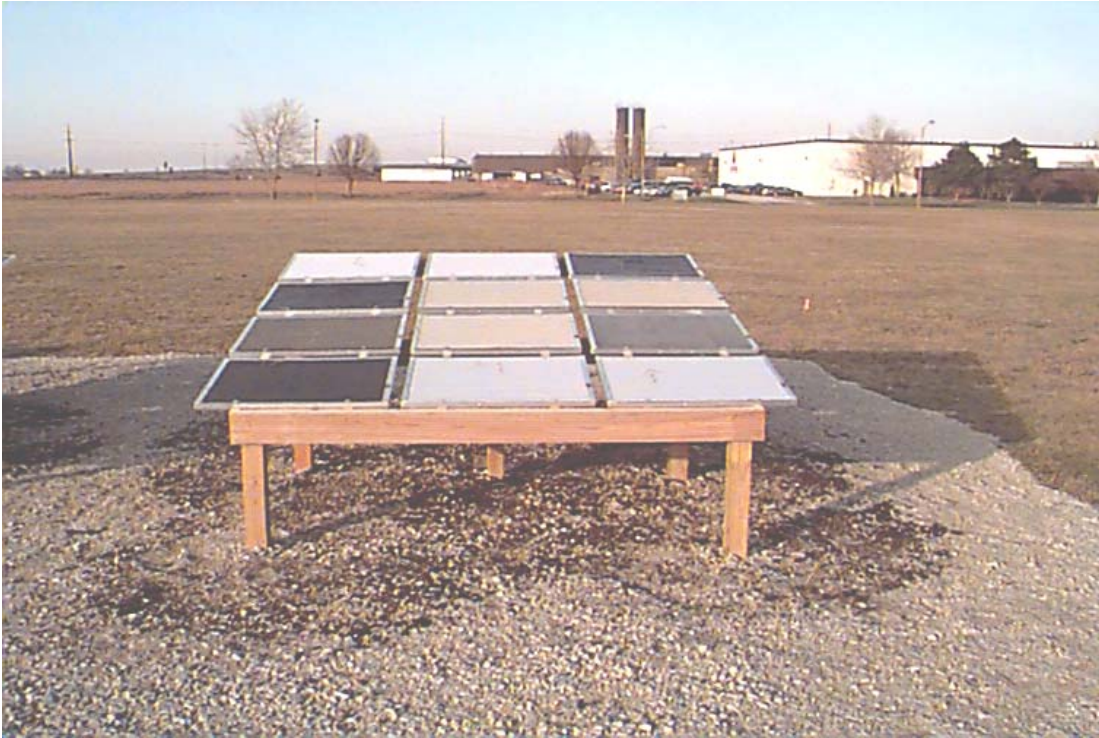
Figure 1. Outdoor exposure table with 12 samples at Champaign, IL weathering site.

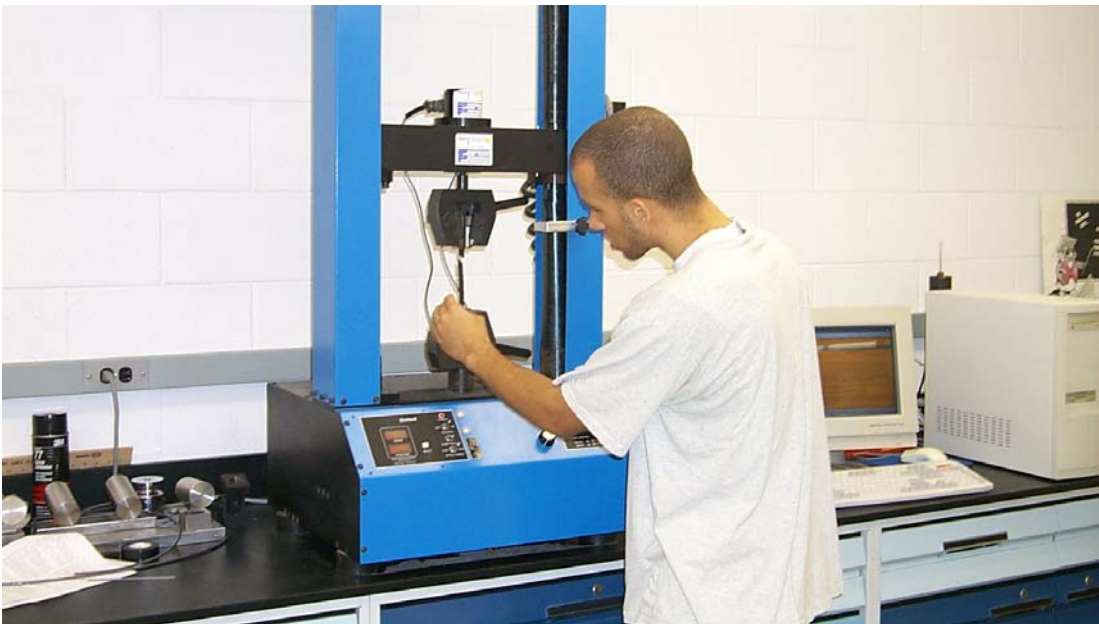
Figure 2. Tensile testing of membrane samples.

Pull tests were conducted on samples using a tensile testing machine as shown in Figure 2. All of these tests used an initial jaw-separation gap of 100 mm and a jaw-separation rate of 0.85 mm/sec. These samples generated three types of load-strain curves. A relatively straight line was generated by each EPDM rubber sample (Figure 3). The TPO samples each generated a sharp peak when the reinforcement ruptured followed by a long tail until the sample ruptured (Figure 4). All of the other samples ruptured at the peak load (Figure 5).

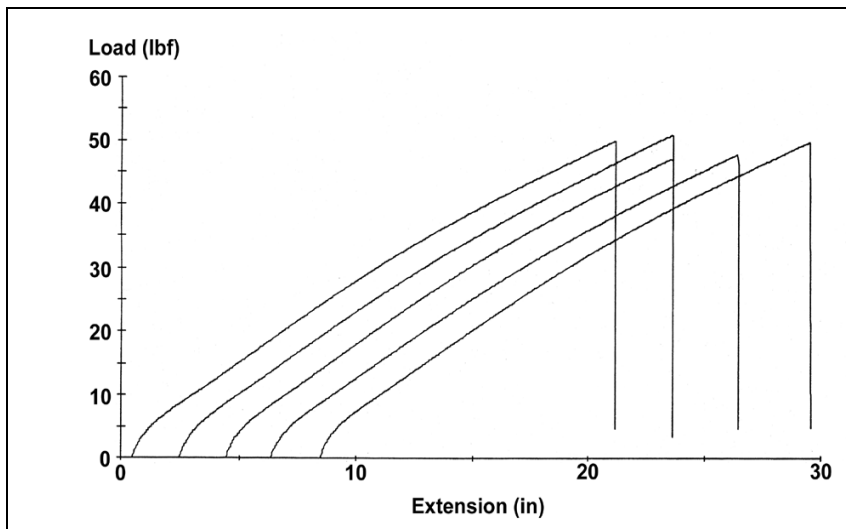
Figure 3. EPDM load-strain curve.

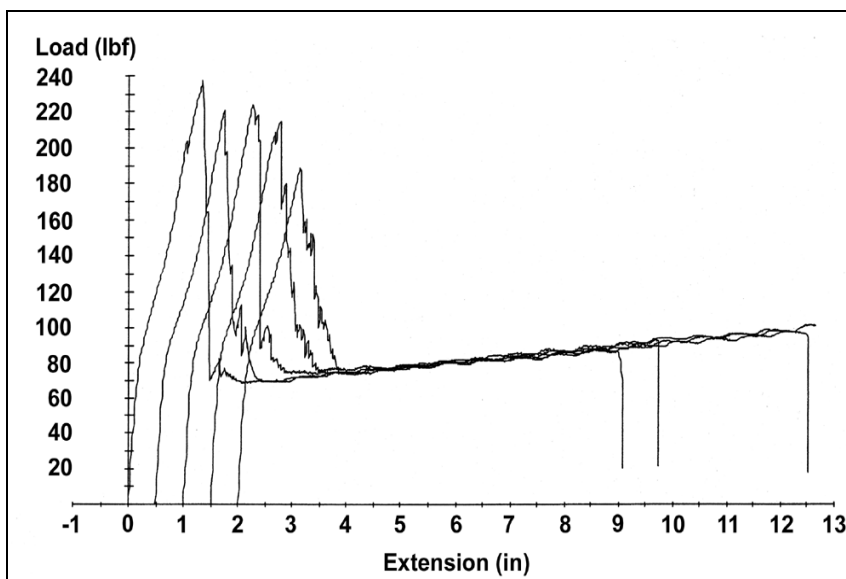
Figure 4. TPO load-strain curve.

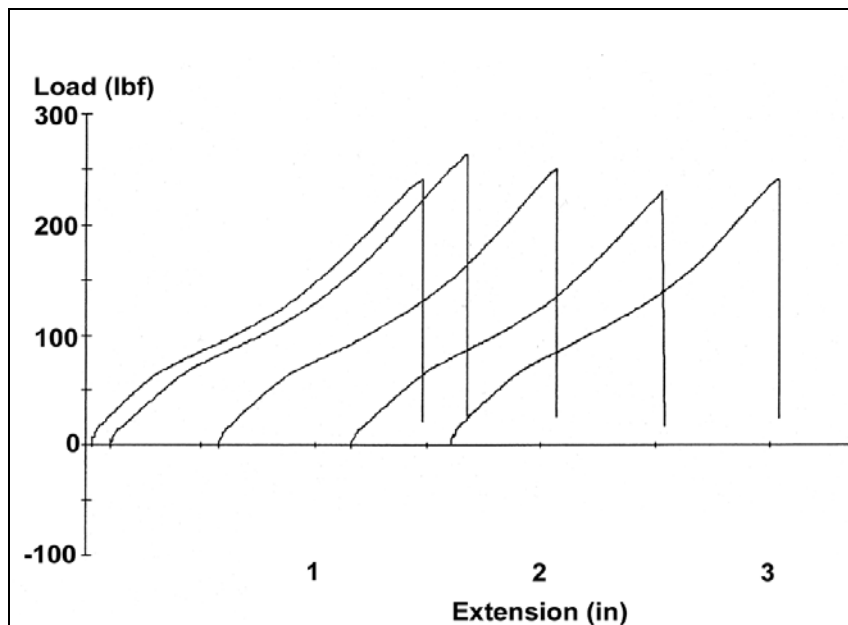
Figure 5. PVC load-strain curve.

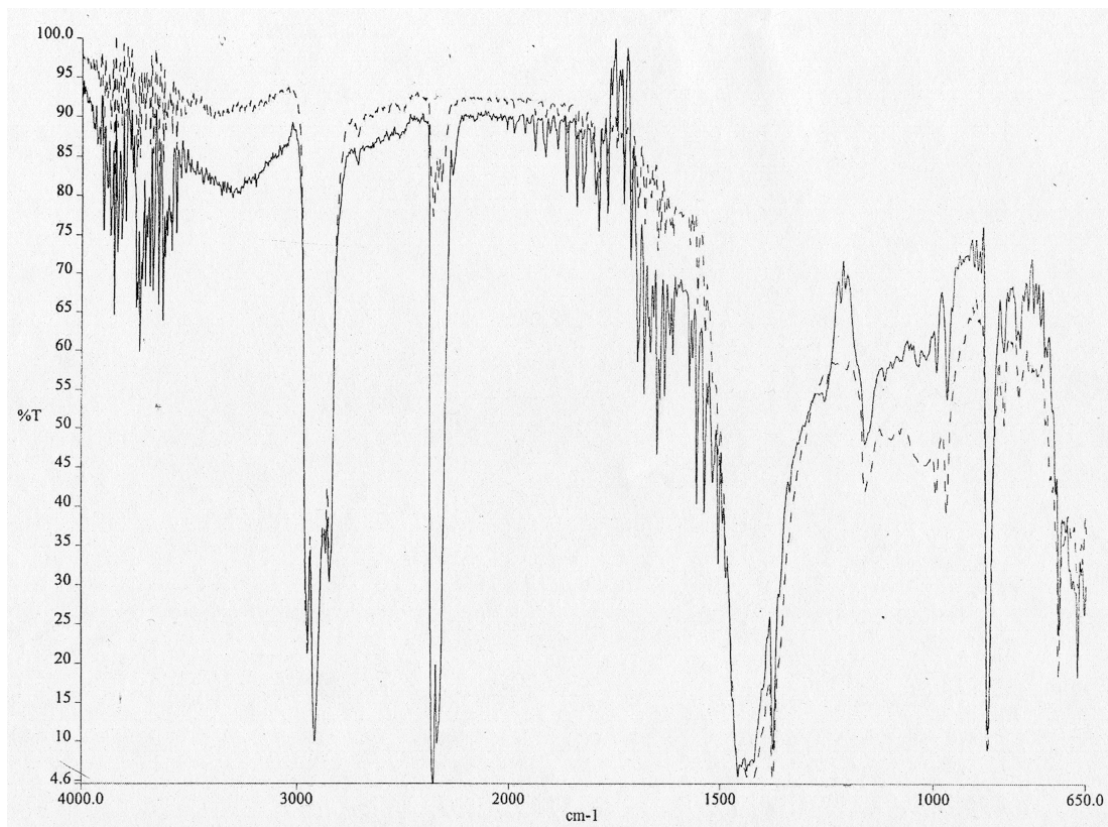
Sample A (TPO), bottom surface.

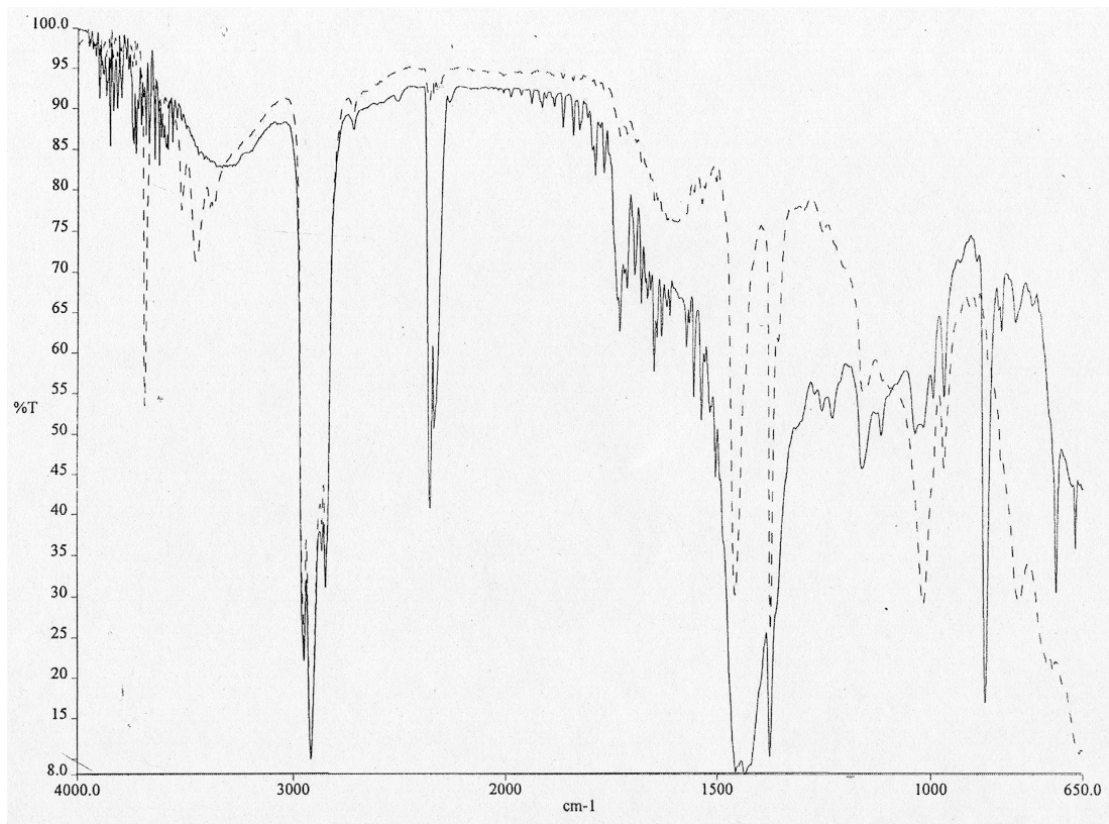
**Sample A (TPO), top surface.**

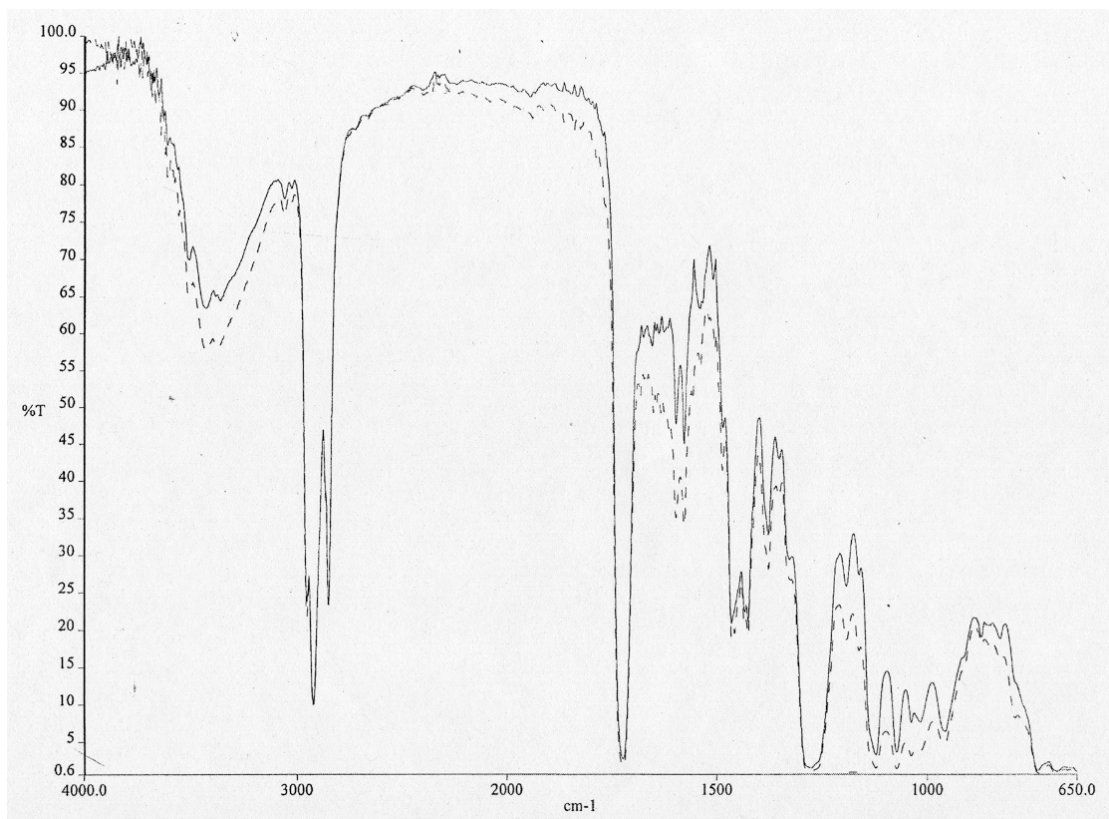
**Sample B (PVC alloy), top surface.**

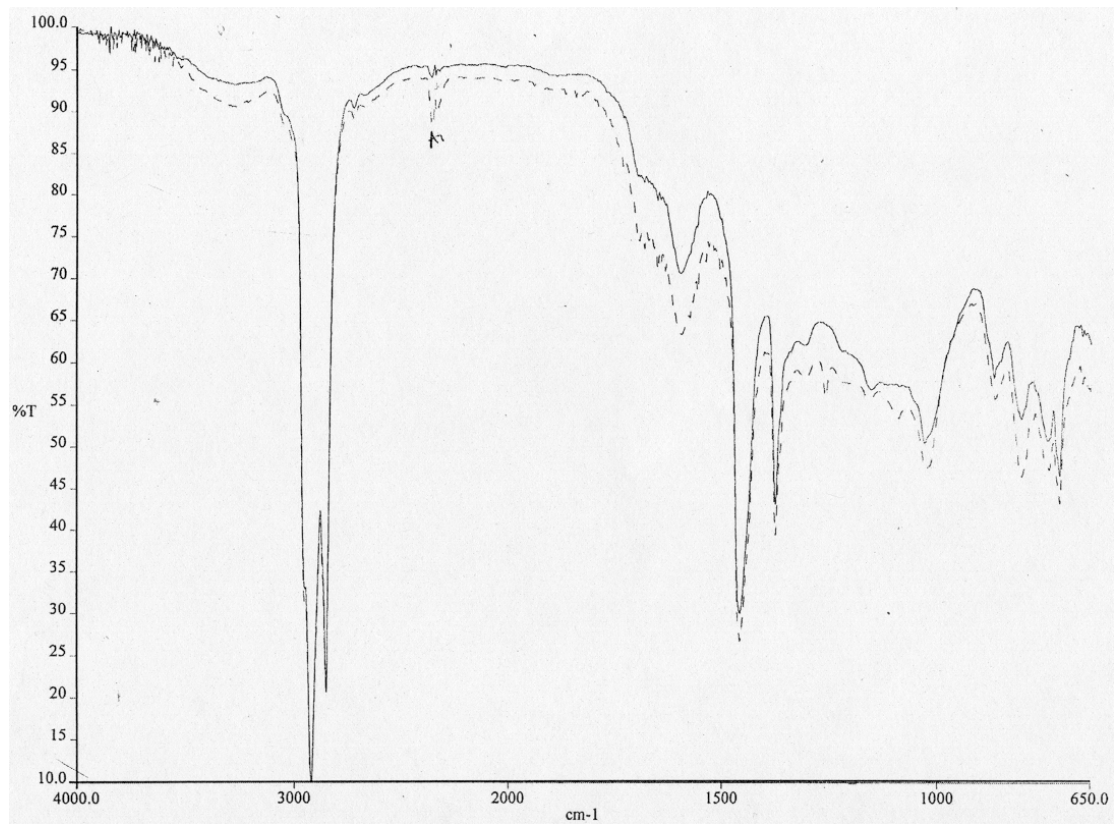
**Sample C (BUR), top surface.**

**Samples C (BUR) and D (BUR).** No significant changes were observed. There may be a slight increase in the -C=O (carbonyl groups).

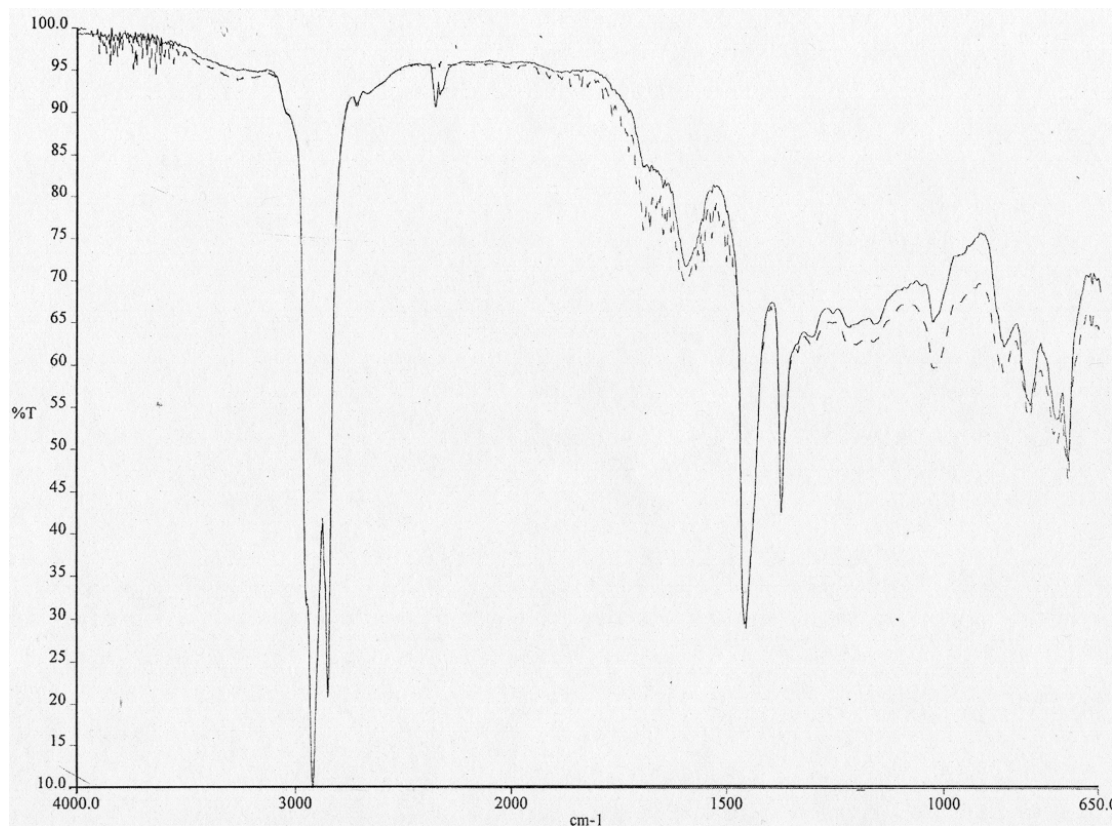
**Sample D (BUR), top surface.**

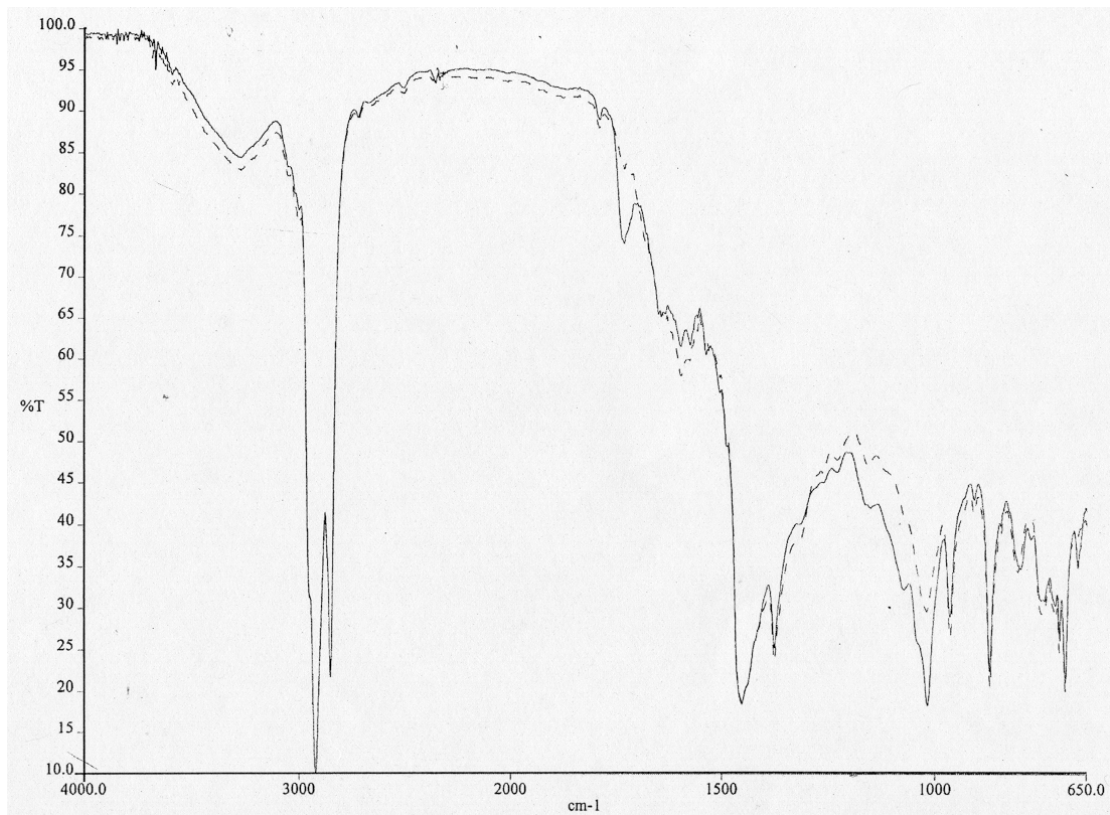
**Sample E (SBS MB), granular surfacing removed.**

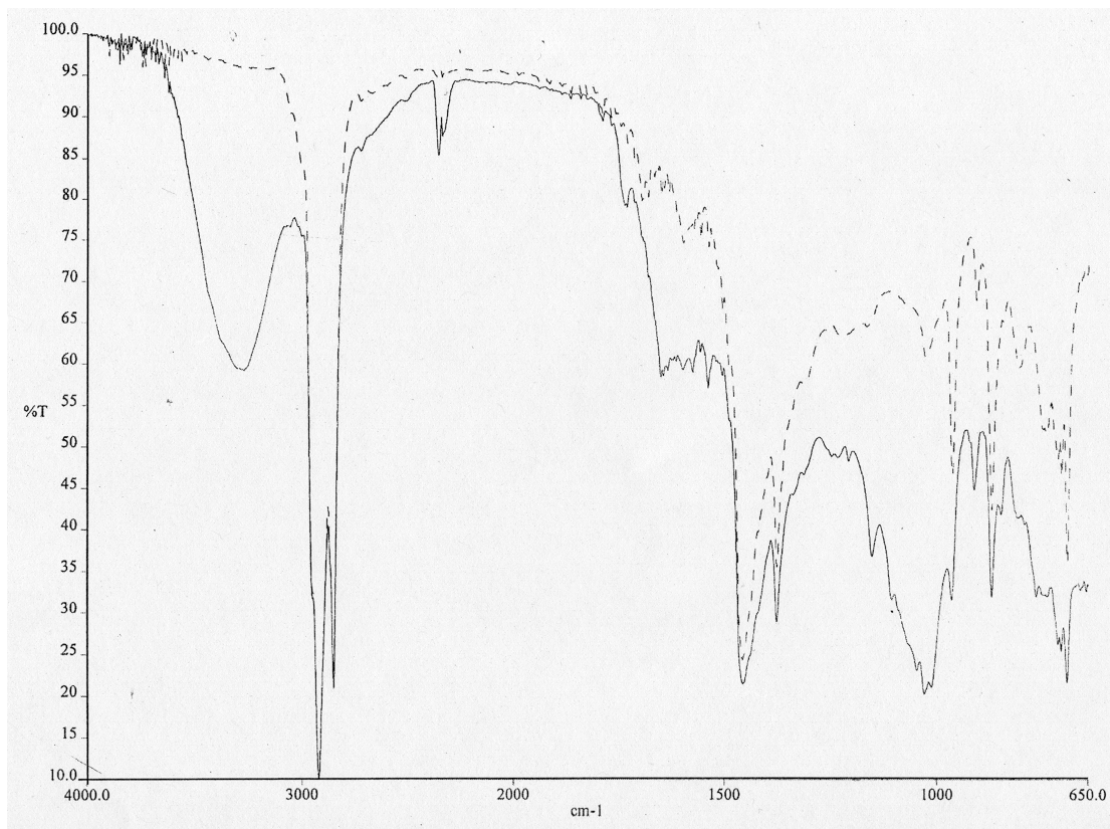
**Sample F (SBS MB), granular surfacing removed.**

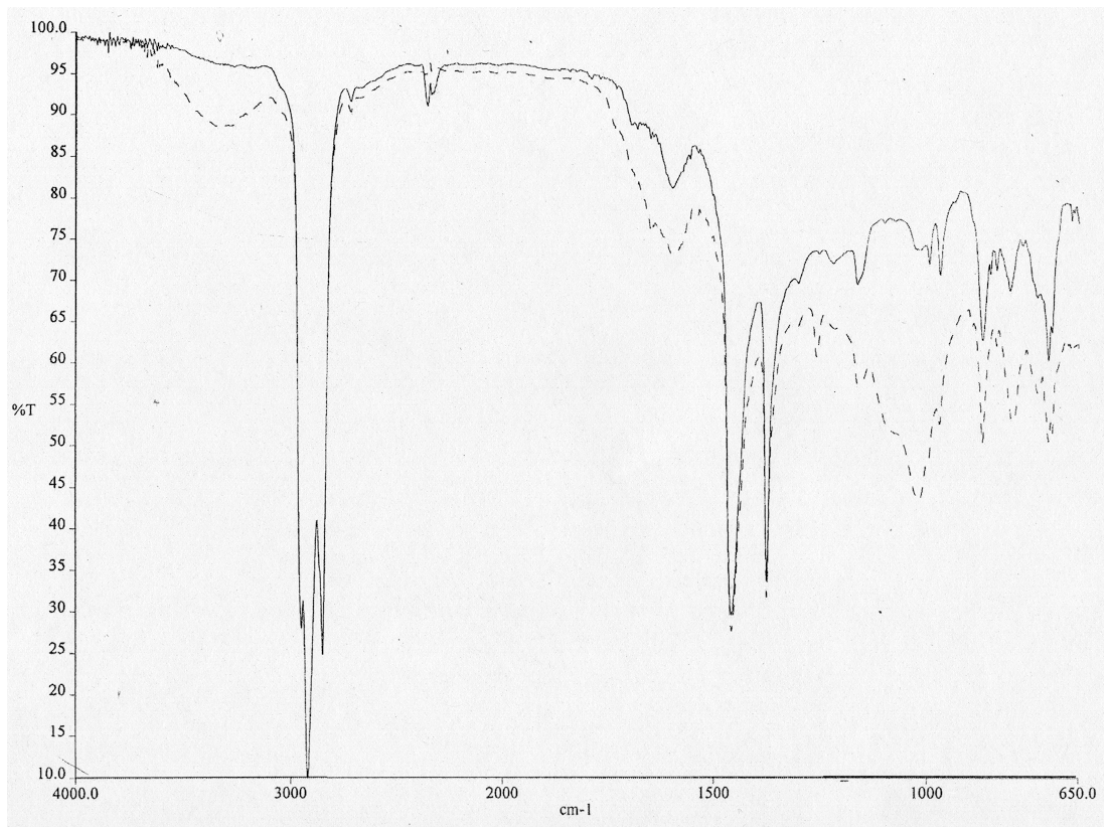
**Sample G (APP MB), granular surfacing removed.**

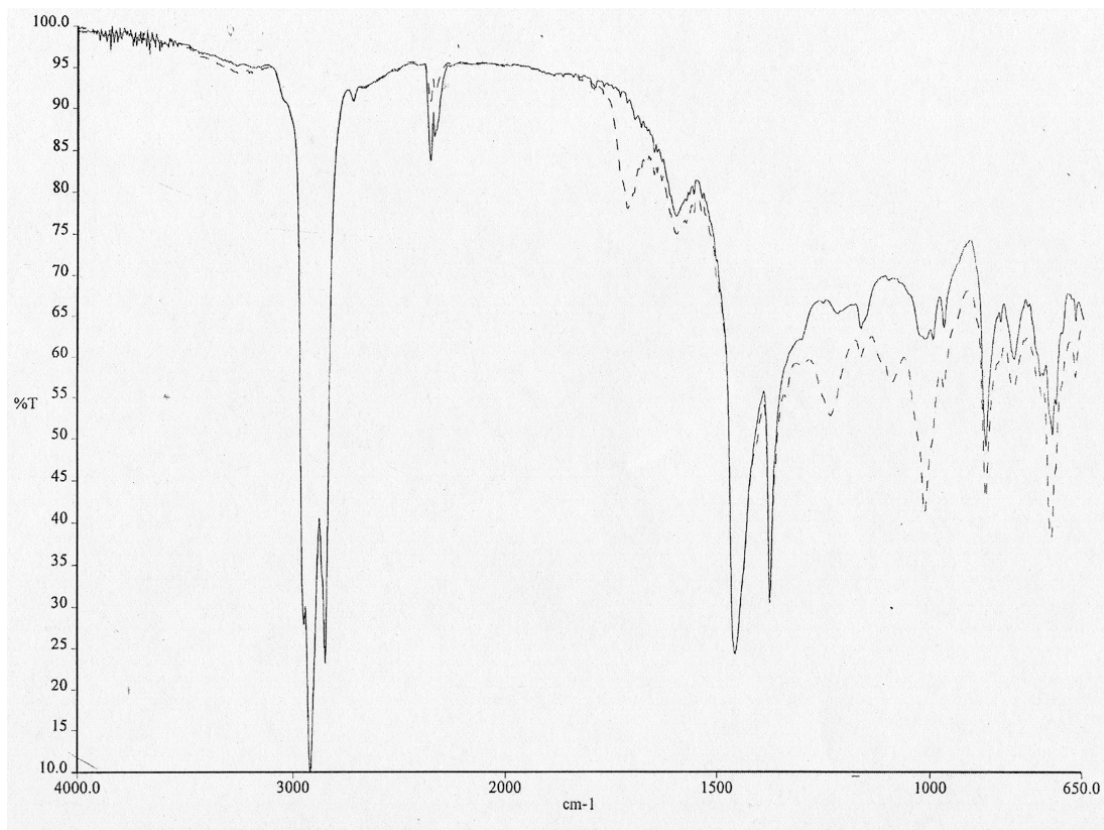
**Sample H (APP MB), granular surfacing removed.**

**Sample H (APP MB).** An increase was observed in -C=O groups and in unidentified groups near 1000, 1100, and 1300  $\text{cm}^{-1}$ .

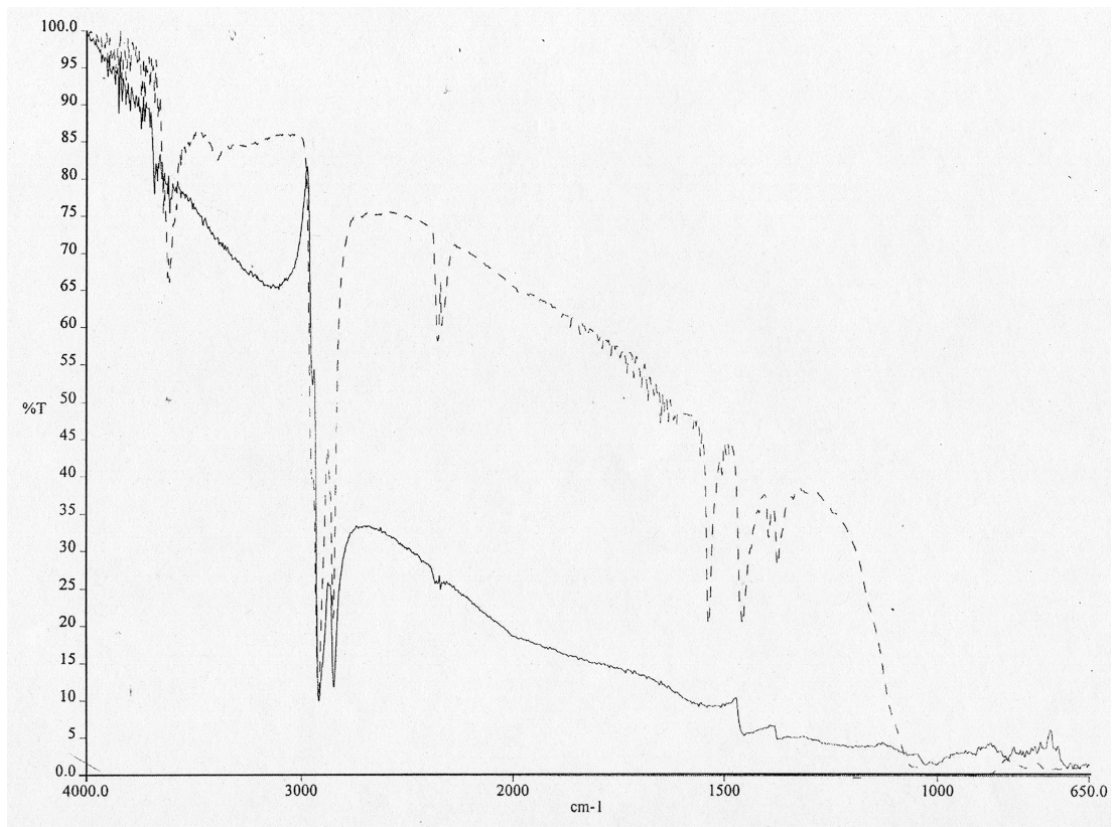
**Sample J (EPDM).**

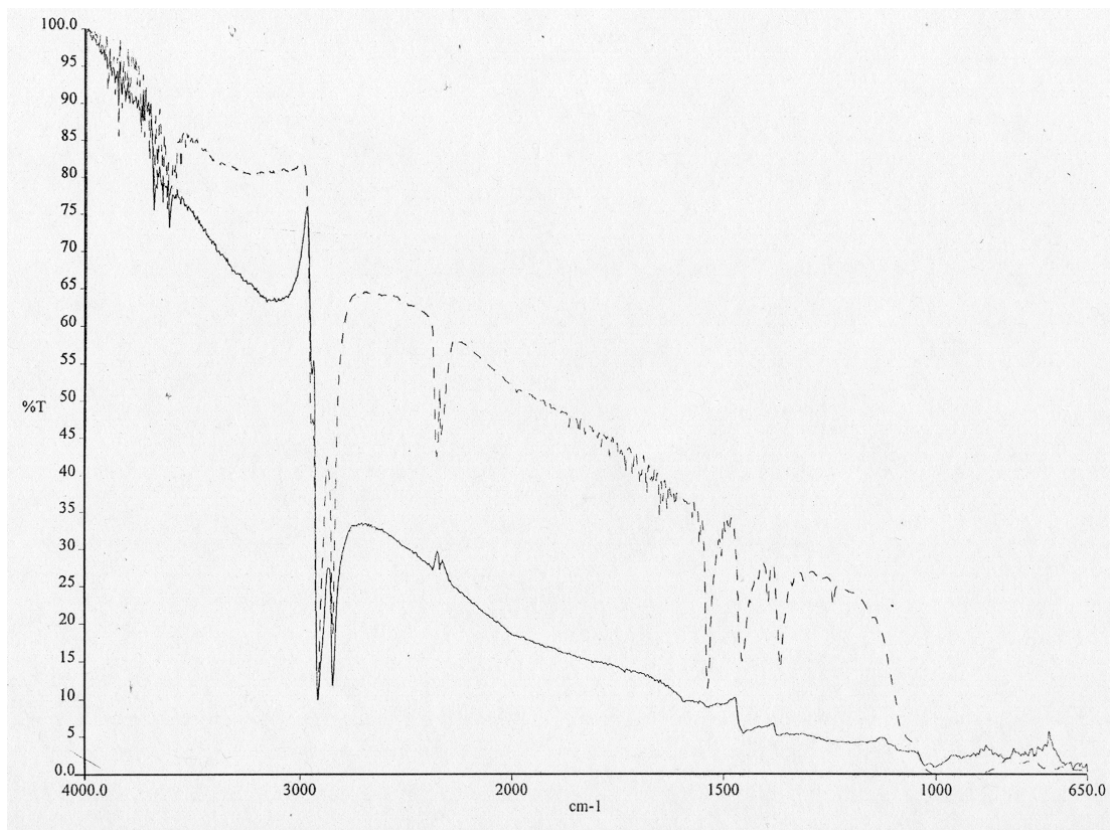
**Sample K (EPDM).**

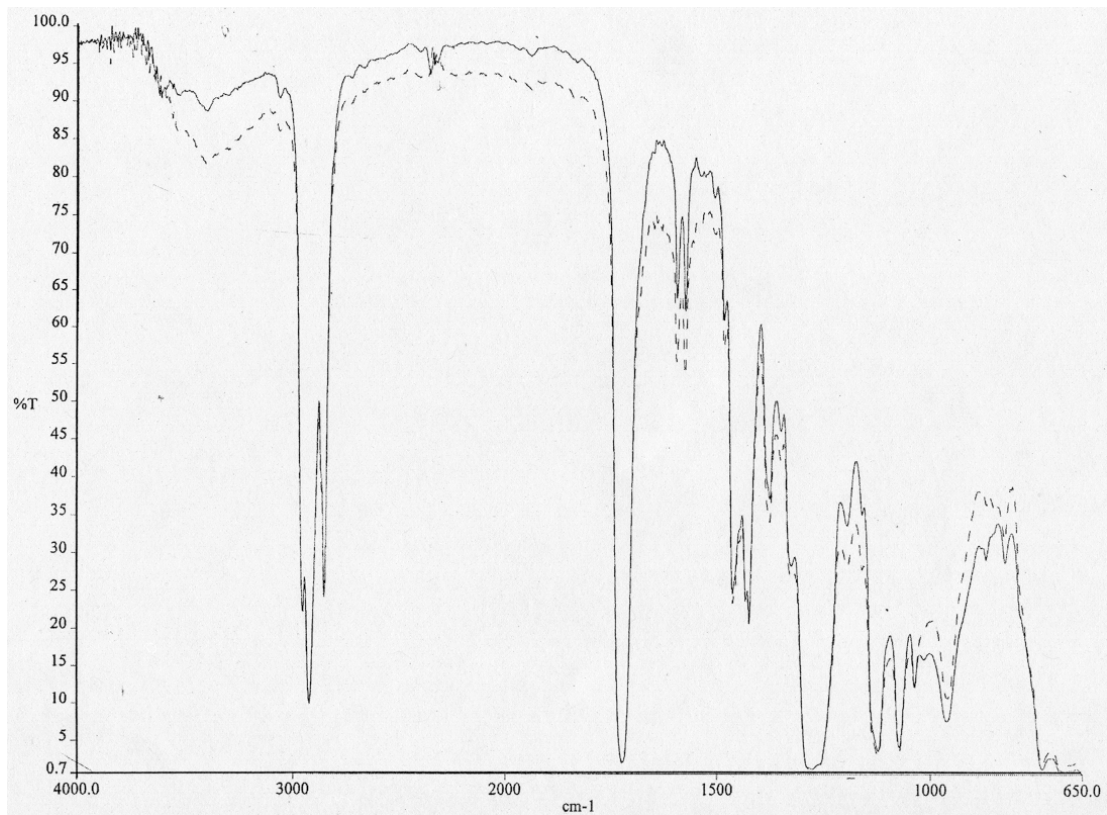
**Sample L (PVC), top surface.**

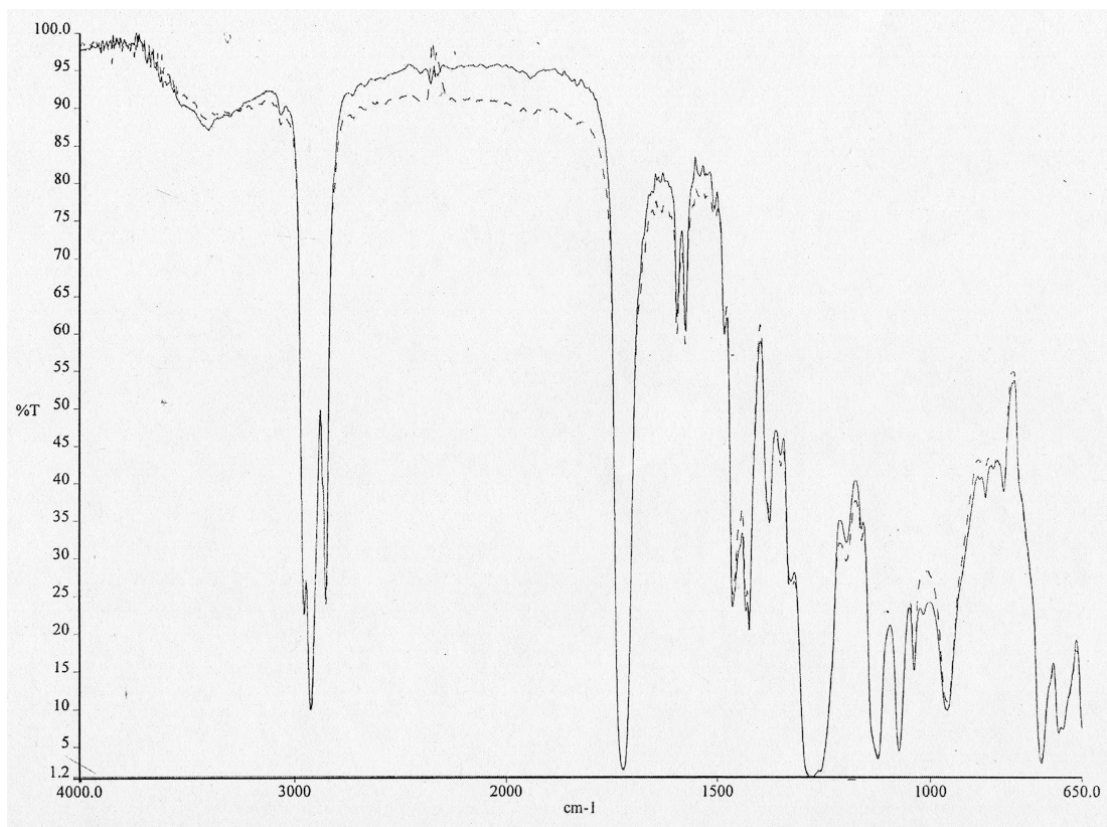
**Sample L (PVC), bottom surface.**

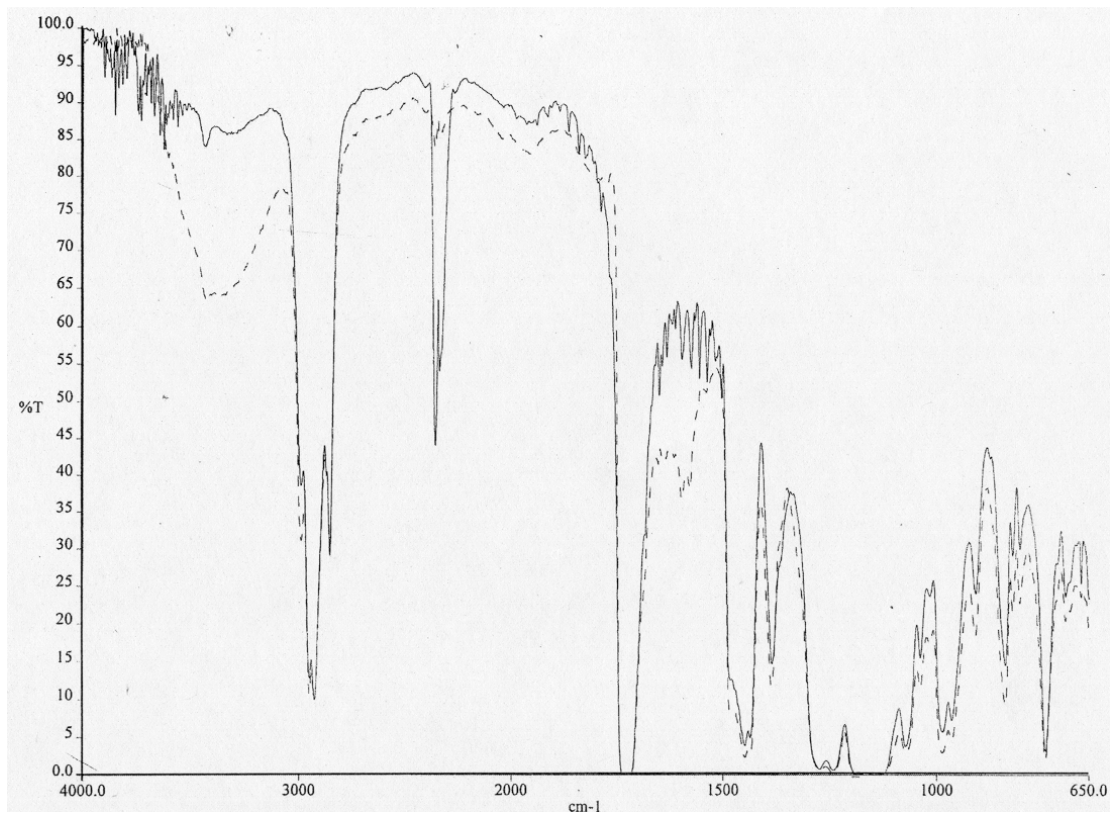
Sample M (PVC), top surface.

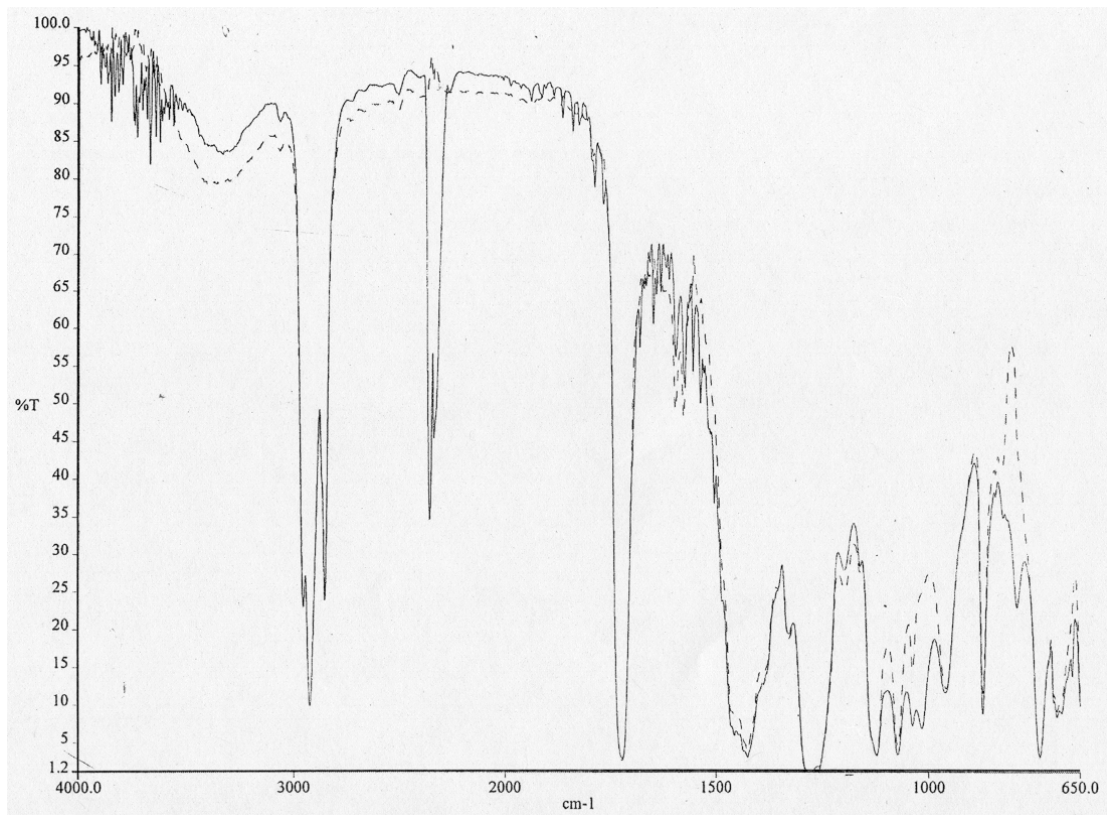
Sample M (PVC), bottom surface.
